# RESULTS OF THE FIRST UNITED STATES MANNED ORBITAL SPACE FLIGHT

FEBRUARY 20, 1962

Manned Spacecraft Center  
NATIONAL AERONAUTICS AND SPACE ADMINISTRATION

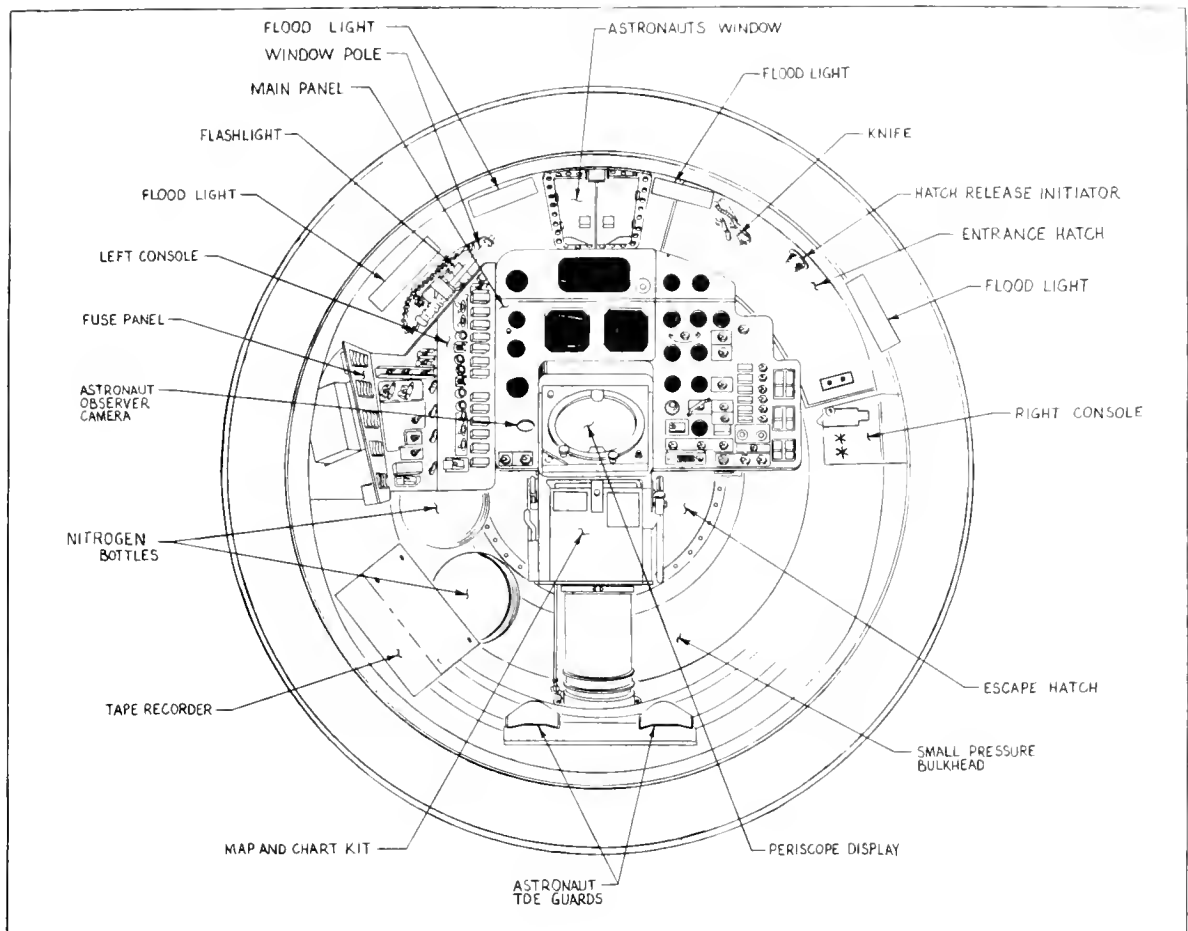
FIGURE 2-3.—Spacecraft cabin arrangement.

A window is provided, in the conical section over the astronaut's head, for the astronaut to use for observations and for obtaining visual attitude references. The astronaut entrance and egress hatch is located in the conical section as indicated by the outline to the astronaut's right. The astronaut can also egress through

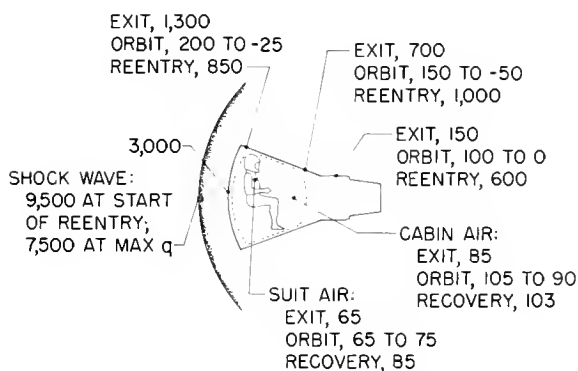
FIGURE 2-7.—Representative temperatures in degrees Fahrenheit.

During the exit flight, when the small end of the spacecraft points in the direction of flight, the afterbody shingles are also subjected to aerodynamic heating, attaining maximum temperatures as high as about 1,300° F. With the local temperatures dependent upon local flow conditions and the thermal mass of the spacecraft surface.

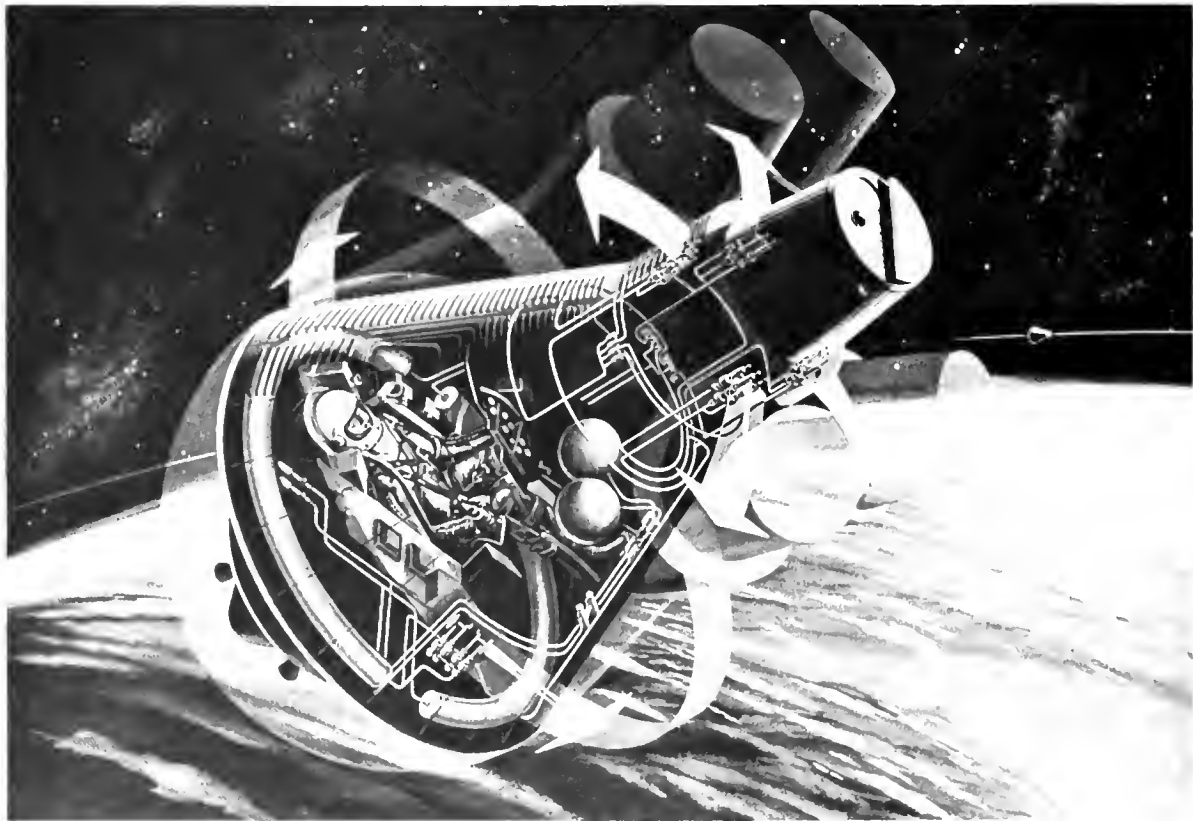
FIGURE 2-11.—Arrangement of reaction control system.

The thruster impulse is directed by the four basic control modes through 18 individual system, as shown in figure 2-11. Figures thrusters—12 on system A and 6 on the manual 2-12(a) and 2-12(b) show the A and B systems RCS schematic diagrams. Figures 2-12(a) and 2-12(b) do not show completely the methods of electrically controlling the thrusters; in figure 2-12(a) there is a switch missing between the hand controller and the ASCS control box which permits selection of either FBW or ASCS. Similarly, in figure 2-12(b) the connection of the hand controller through a switch and the ASCS control box to the thruster solenoids for RSCS control is missing. Metered quantities of hydrogen peroxide are decomposed in silver-plated catalyst beds in each of the thruster chambers to provide the desired impulse. Twelve of the thrusters used on the Mercury spacecraft are sized to provide adequate control during the retromaneuver.

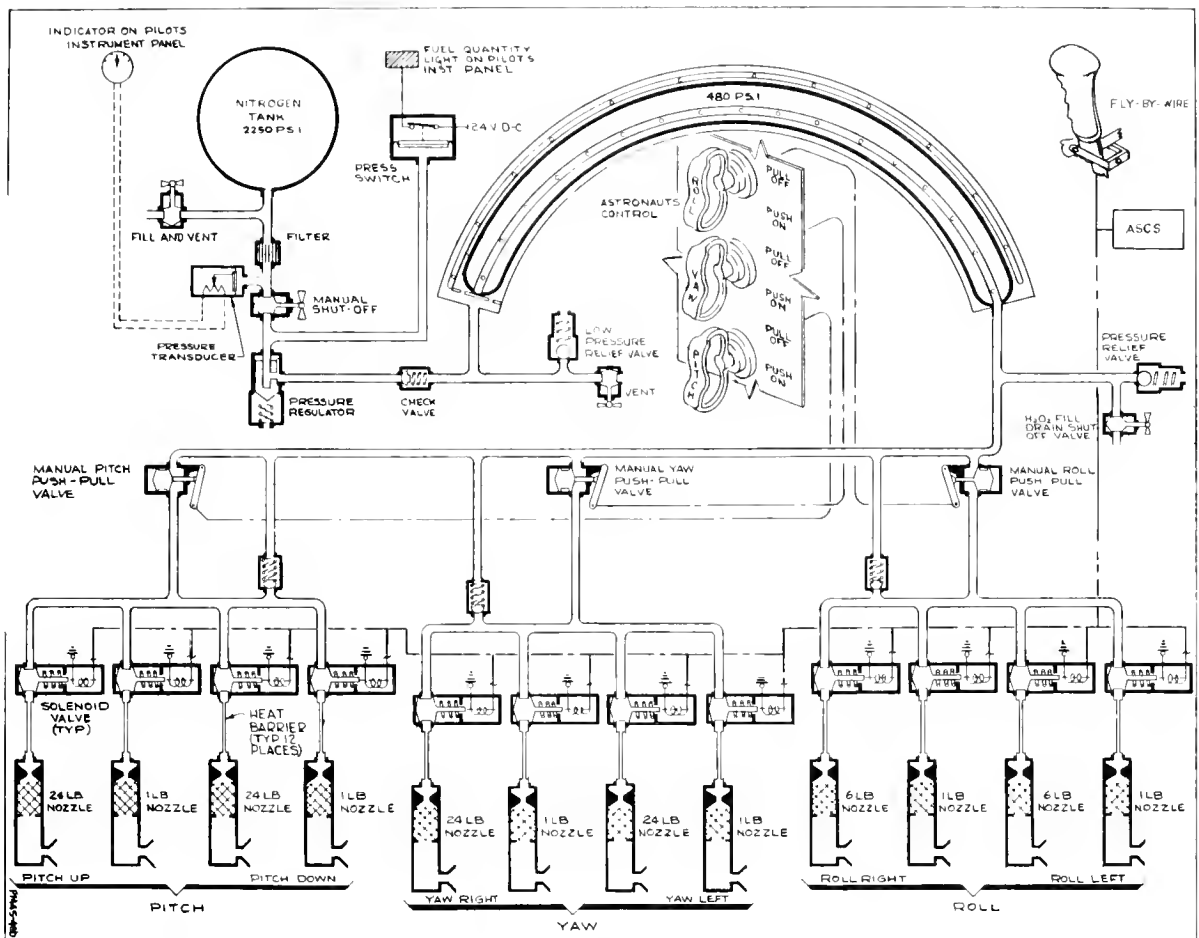
(a) System A.

FIGURE 2-12.—Reaction control system schematic diagrams.

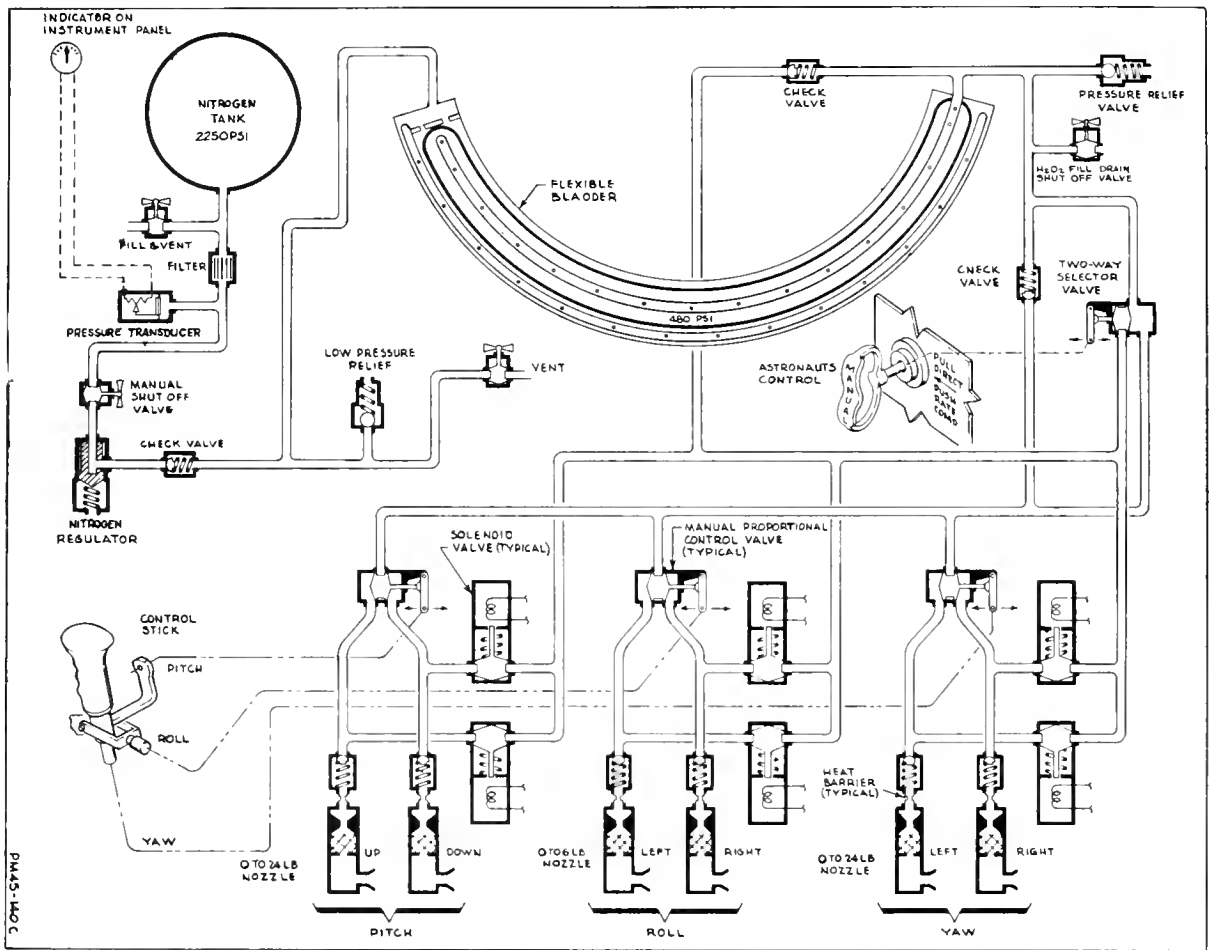
(b) System B.

FIGURE 2-12.—Concluded.

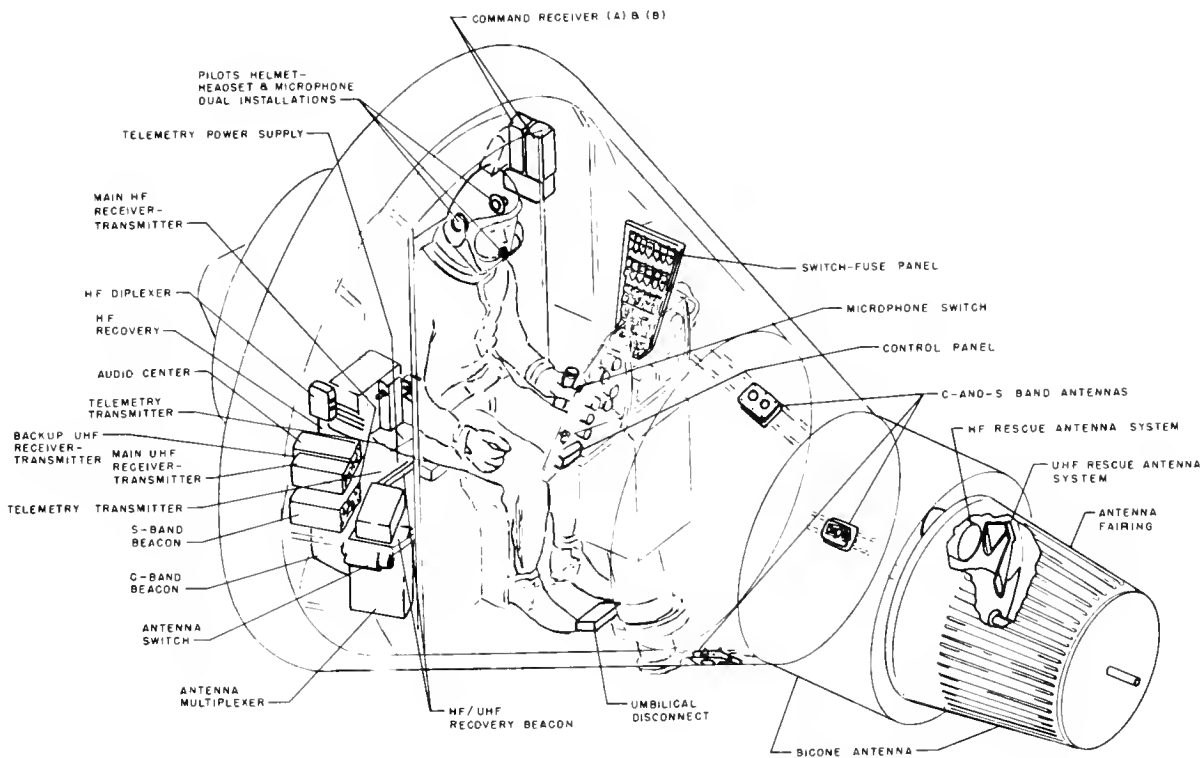
FIGURE 2-13.—Locations of major components of communications system.

The spacecraft communications and instrumentation systems consisted of voice, radar, command, recovery, and telemetry links. Each system had main and backup (or parallel) equipment for redundancy, with selection of the desired system generally at discretion of the astronaut through switches mounted on the instrument panel. Table 2-II is a list of the systems, and figure 2-13 shows the physical lo-

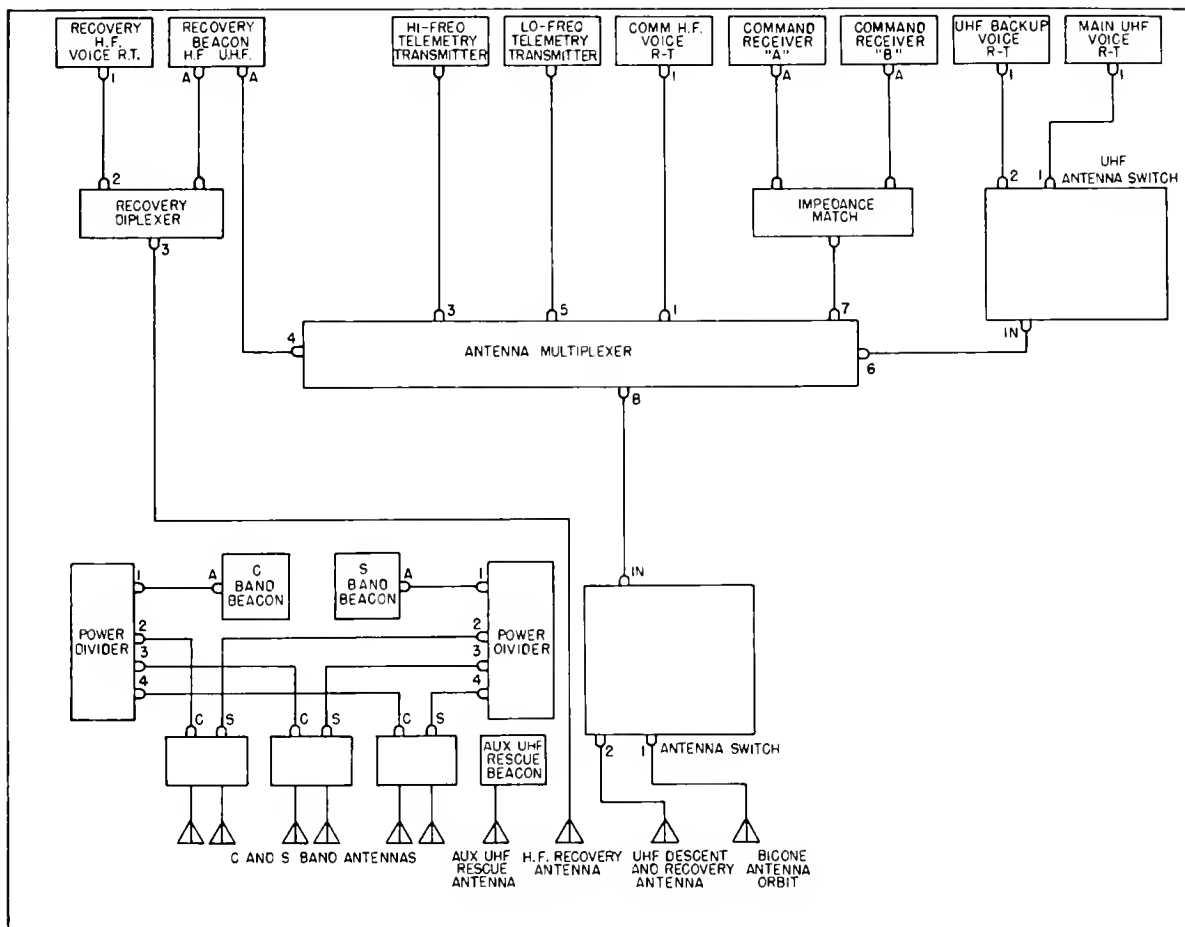
FIGURE 2-15.—Communications and antenna systems schematic diagram.

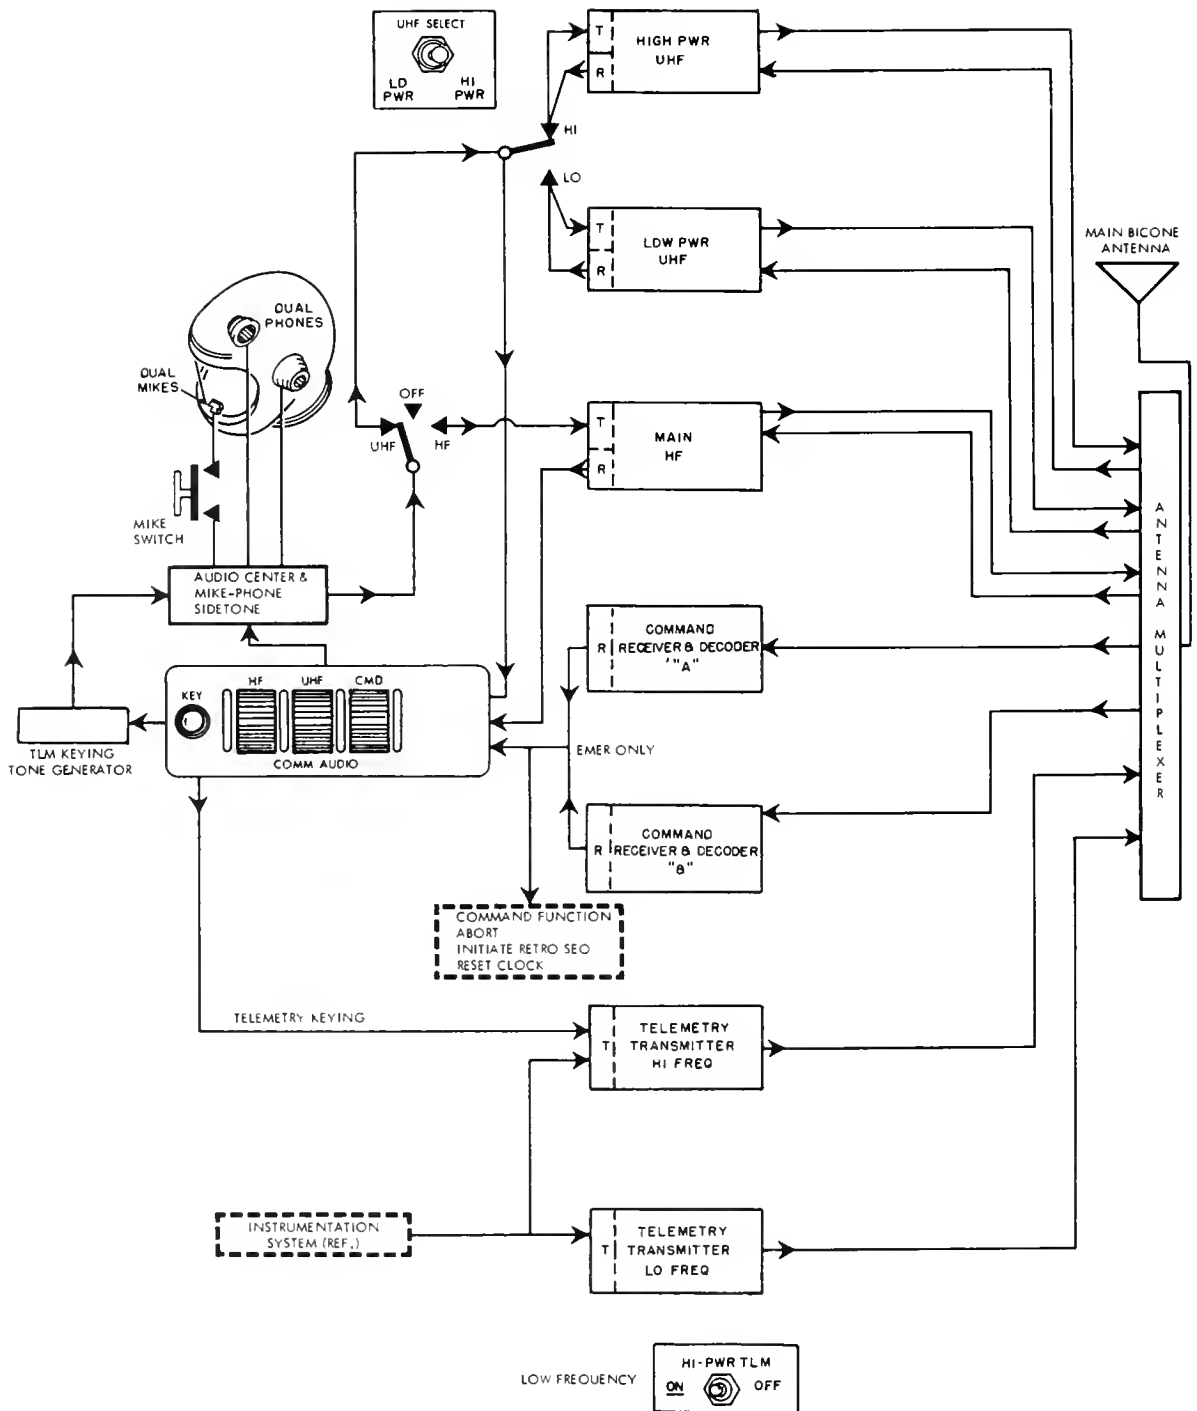
FIGURE 2-16.—Voice systems schematic diagram.

perience and ground tests, it was known that the HF system had somewhat poorer voice fidelity but longer range than the UHF system. The UHF system, because of its slightly better voice quality, was considered to be the primary system. From previous experience, it was known that the range of the UHF system was approximately equal to the line-of-sight range and was entirely adequate for a normal mission. The main voice traffic was therefore conducted on the UHF system, with a small amount of traffic conducted on the HF system to verify system operation. It might be noted that the UHF system consisted of a main and a backup transmitter-receiver. Thus, three separate voice systems were available for choice of the astronaut—HF, UHF main, and UHF backup—as shown in figure 2-16. Also, a redundant ground-to-air voice link is available through the command receiver channel. An additional air-to-ground communication link is available to the astronaut by keying the low-frequency telemeter carrier. It should be noted that all of these links use the main bicone antenna through the use of a multiplexer.

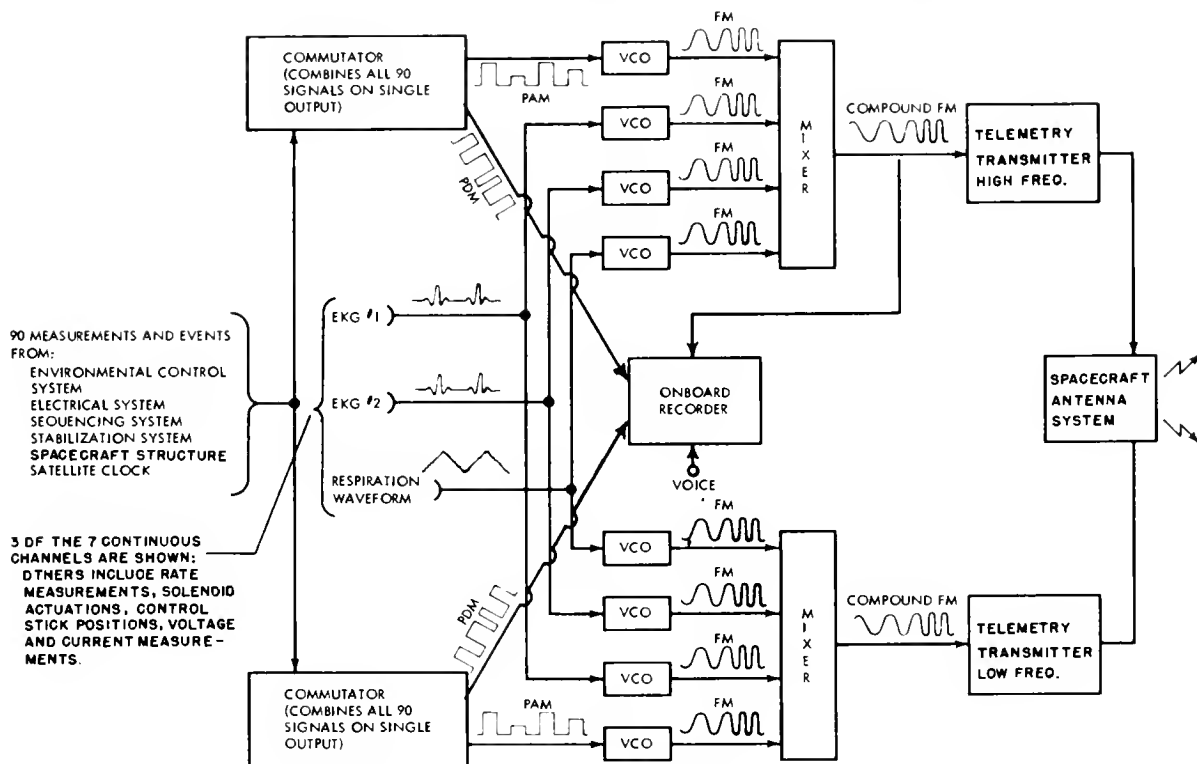
FIGURE 2-18.—Instrumentation system schematic diagram.

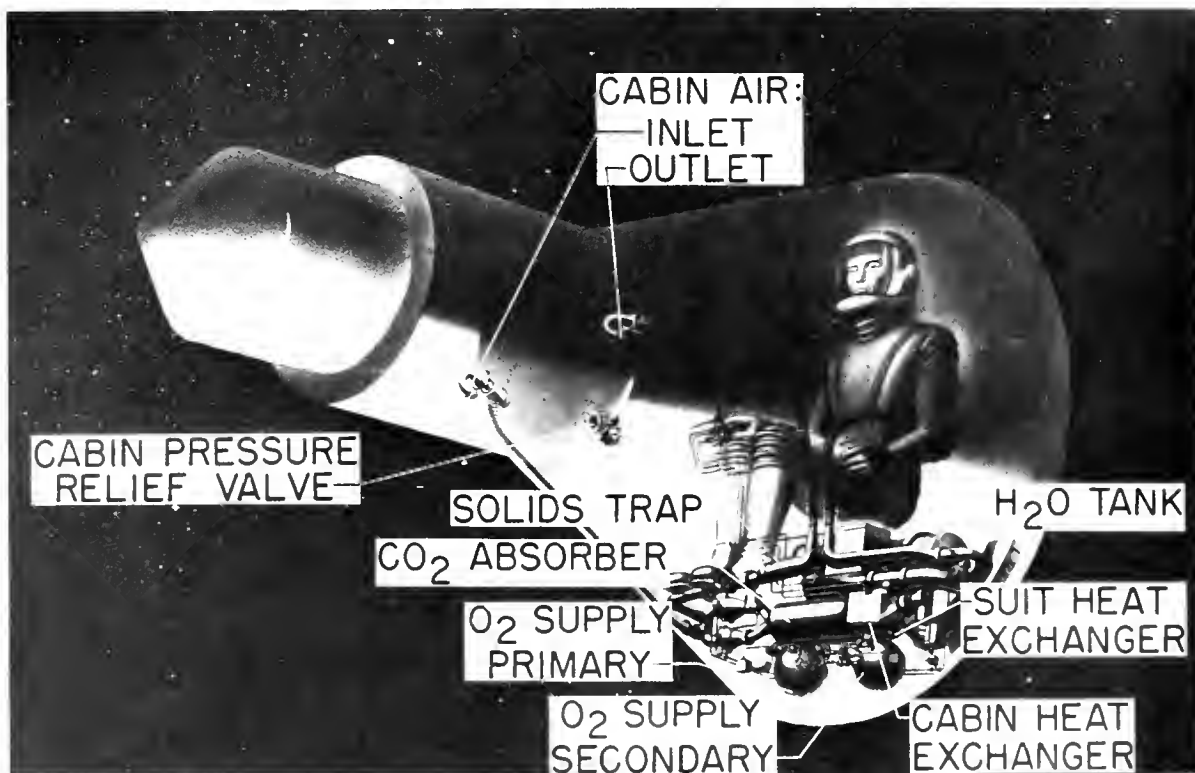
FIGURE 2-19.—Approximate physical arrangement of spacecraft environmental control system.

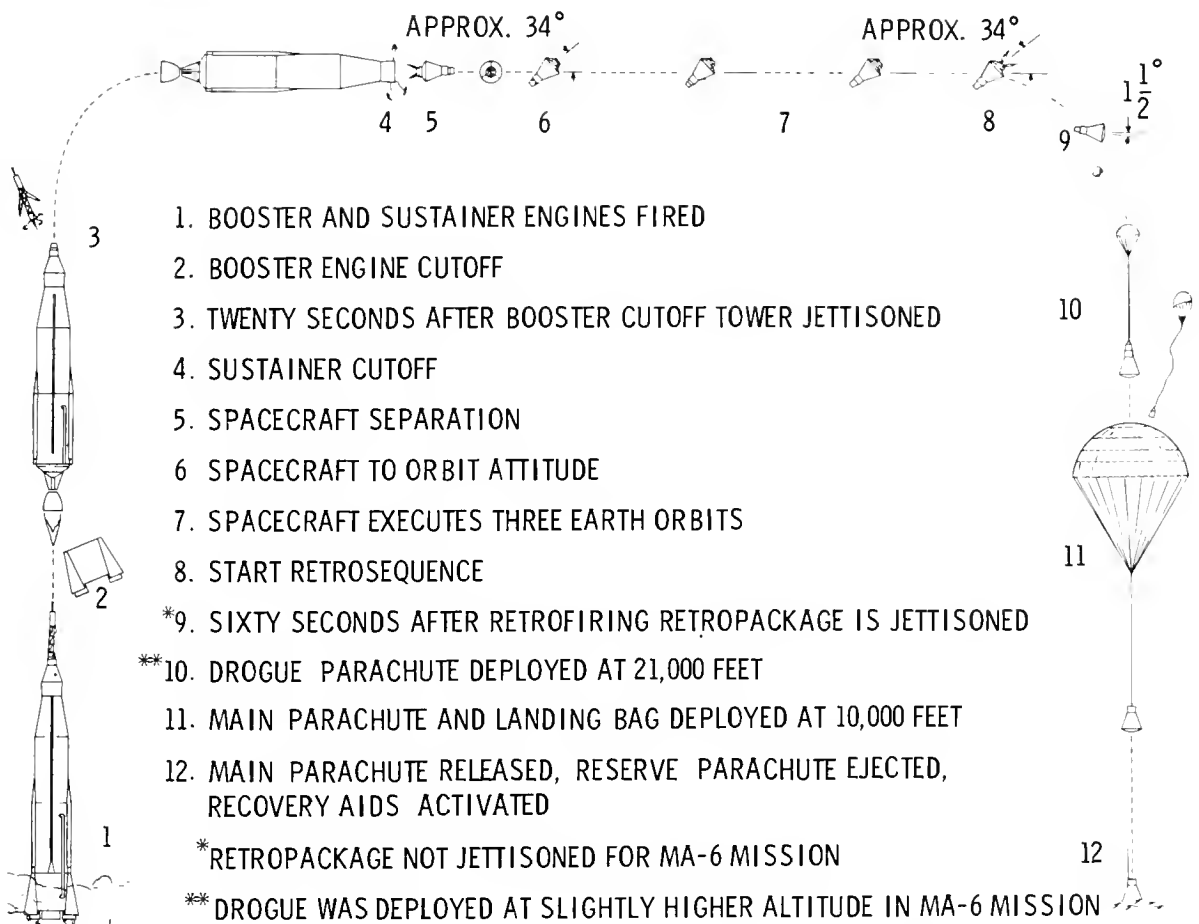
FIGURE 2-22.—Sequence of major events for the MA-6 mission.

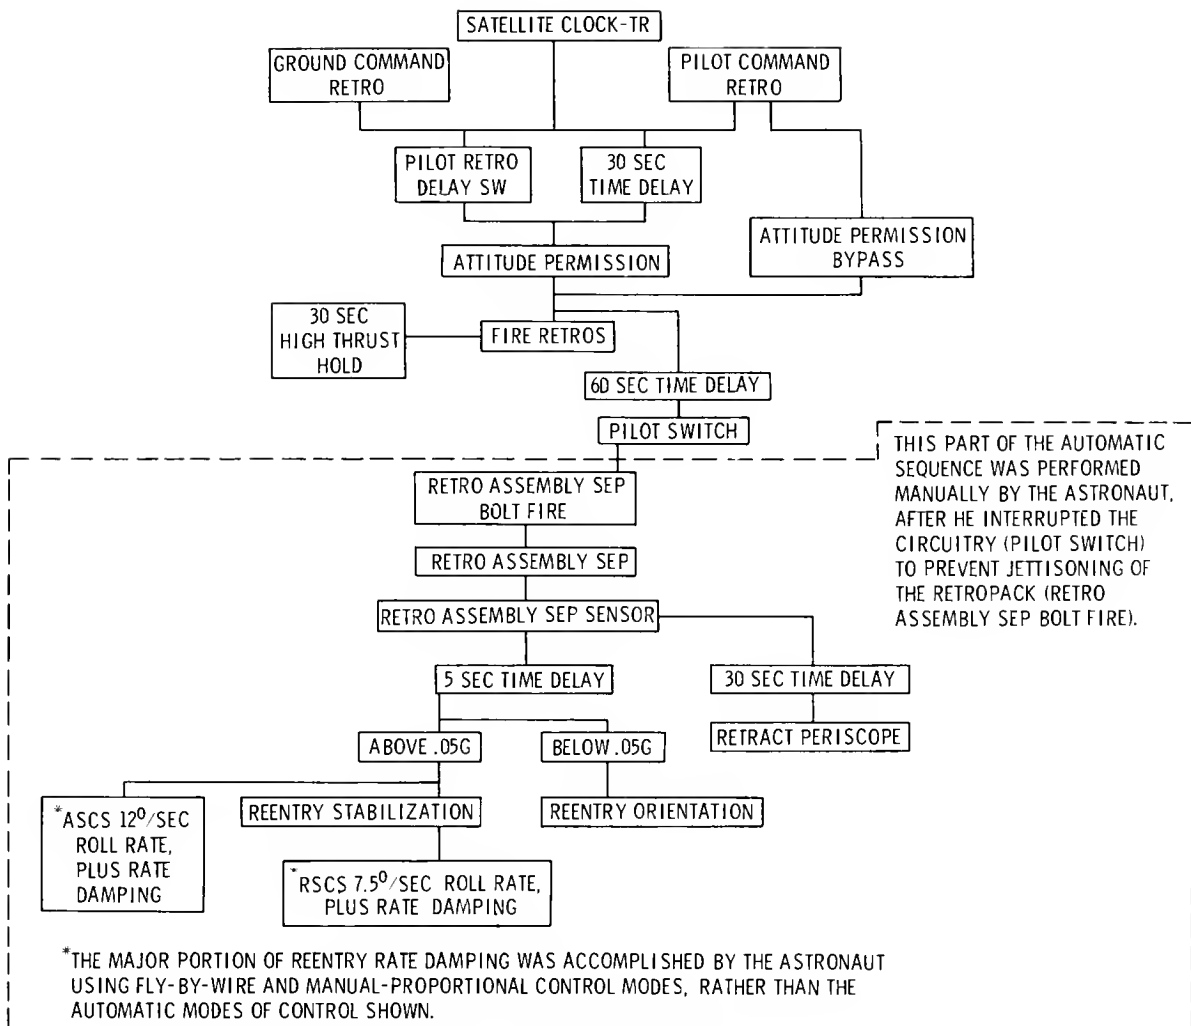
(b) Retrograde and reentry.

FIGURE 2-23.—Continued.

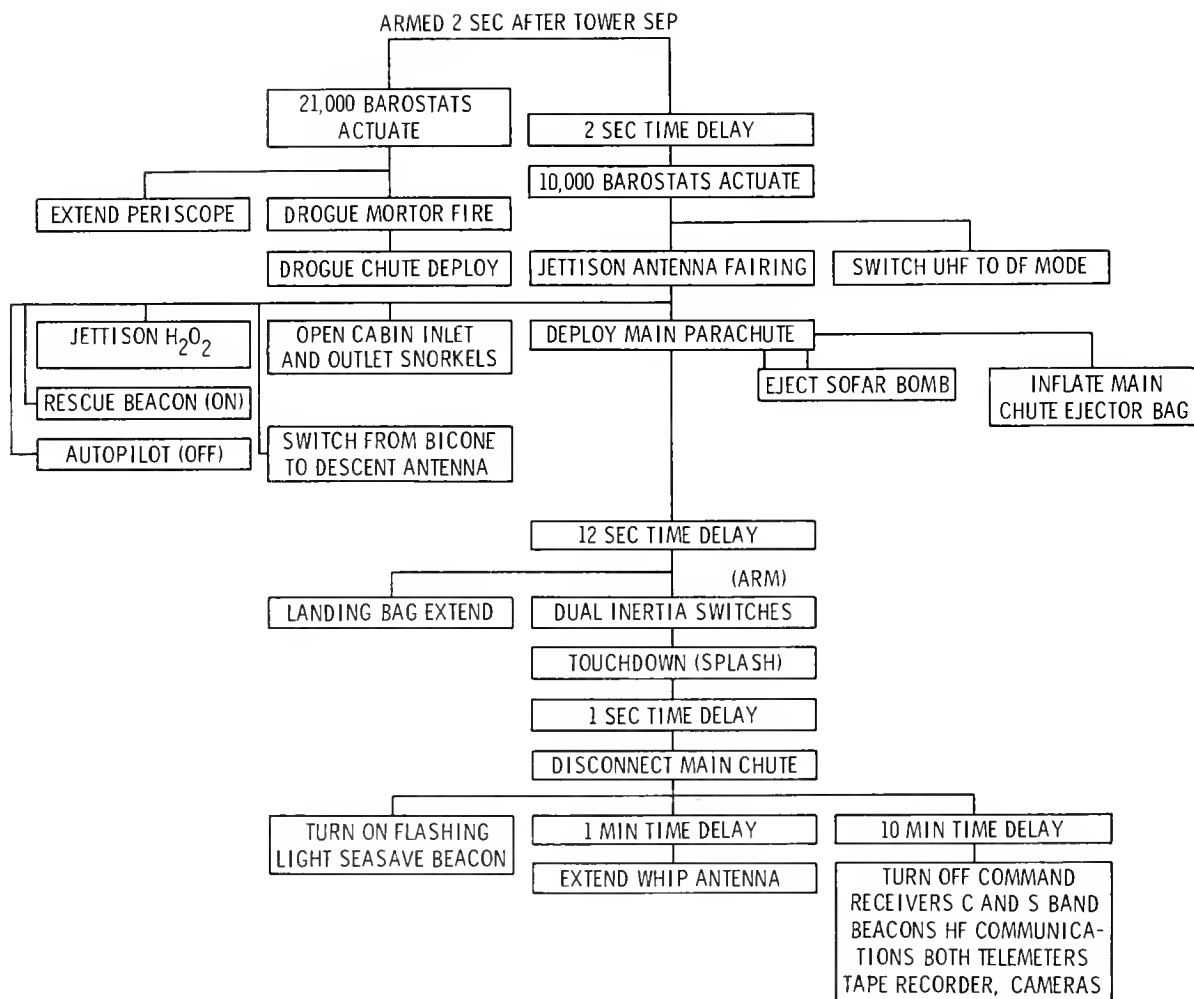
(c) Landing and recovery.

FIGURE 2-23.—Concluded.

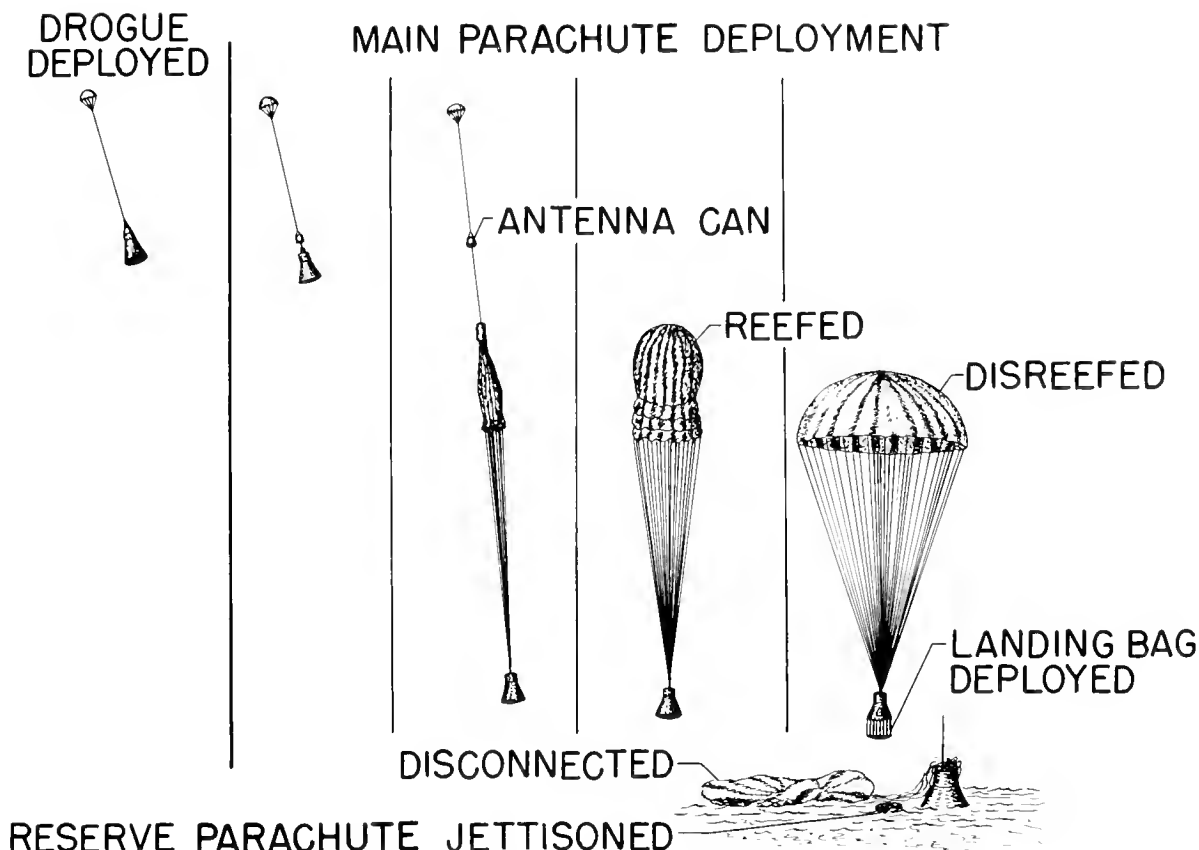
FIGURE 2-24.—Sketch depicting use of spacecraft landing systems.

The landing system is normally actuated at an altitude of about 21,000 feet by either one of two barostats which sense atmospheric pres-

sure. At this time, the drogue parachute is deployed to decelerate and stabilize the spacecraft. At about 10,000 feet, the antenna section and drogue parachute are jettisoned by the signals from another dual barostat and the main parachute is deployed in a reefed condition opened to 12-percent of the maximum diameter for 4 seconds to minimize the opening shock. The main parachute deploys fully after 4 seconds of reefing. A reserve parachute may be deployed by the astronaut in the event the main parachute is unsatisfactory. After main parachute deployment, the landing bag is extended to provide attenuation of the landing load. Immediately after landing, the main parachute is automatically disconnected and the reserve parachute is ejected.

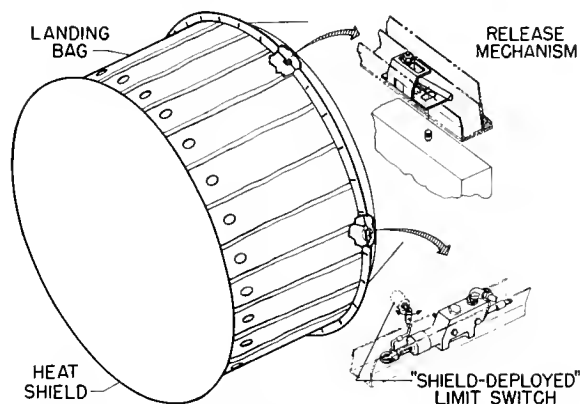
FIGURE 2-25.—Details of heat-shield deployment mechanism and sensing switches.

The "heat-shield-deployed" signal, that is sent to the telemetry system, is furnished by either one of two limit switches which sense the movement of the heat-shield retention devices as shown in figure 2-25. During the orbital flight portion of the MA-6 mission, one of these switches sent a "shield-deployed" signal to the ground monitoring stations. Post-

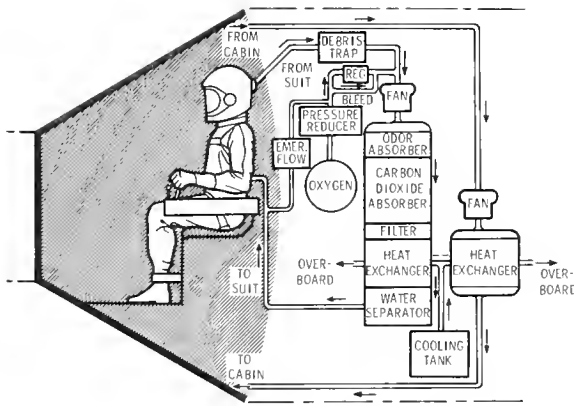
FIGURE 3-2.—Schematic diagram of the Mercury environmental control system.

The pressures in the cabin and pressure suit are maintained at 5.1 psia in normal flight with a 100-percent oxygen atmosphere. The system is designed to control automatically the environmental conditions within the suit and cabin throughout the flight. Manual controls are provided to enable system operation in the event of automatic control malfunction. In describing the environmental control system, it can be considered as two subsystems; the pressure-suit control system and the cabin system. Both of these system operate simultaneously from common coolant water and electrical supplies. The coolant water is stored in a tank with a pressurized bladder system to facilitate weightless flow of water into the heat exchanger. Electrical power is supplied from an onboard battery supply. Oxygen is supplied at an initial

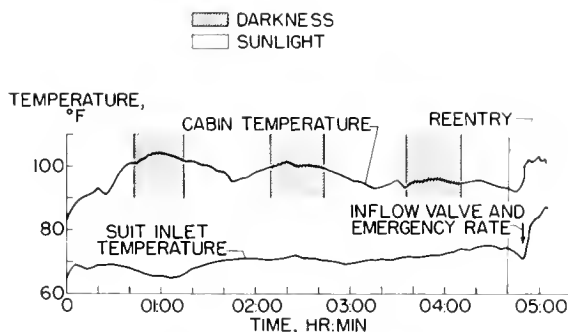
FIGURE 3-3.—Variation of suit and cabin temperatures with time.

The cabin air temperature (fig. 3-3) fluctuated between 90° F and 104° F as the spacecraft passed from darkness into sunlight. The astronaut reported that at least five attempts to reduce cabin air temperature by increasing water flow to the cabin heat exchanger resulted in the illumination of the excess-water light. This light indicated that the cabin heat ex-

changer was operating near its maximum capacity for the existing conditions. Even so, the mean cabin air temperature was steadily reduced during the mission after the first hour in orbit.

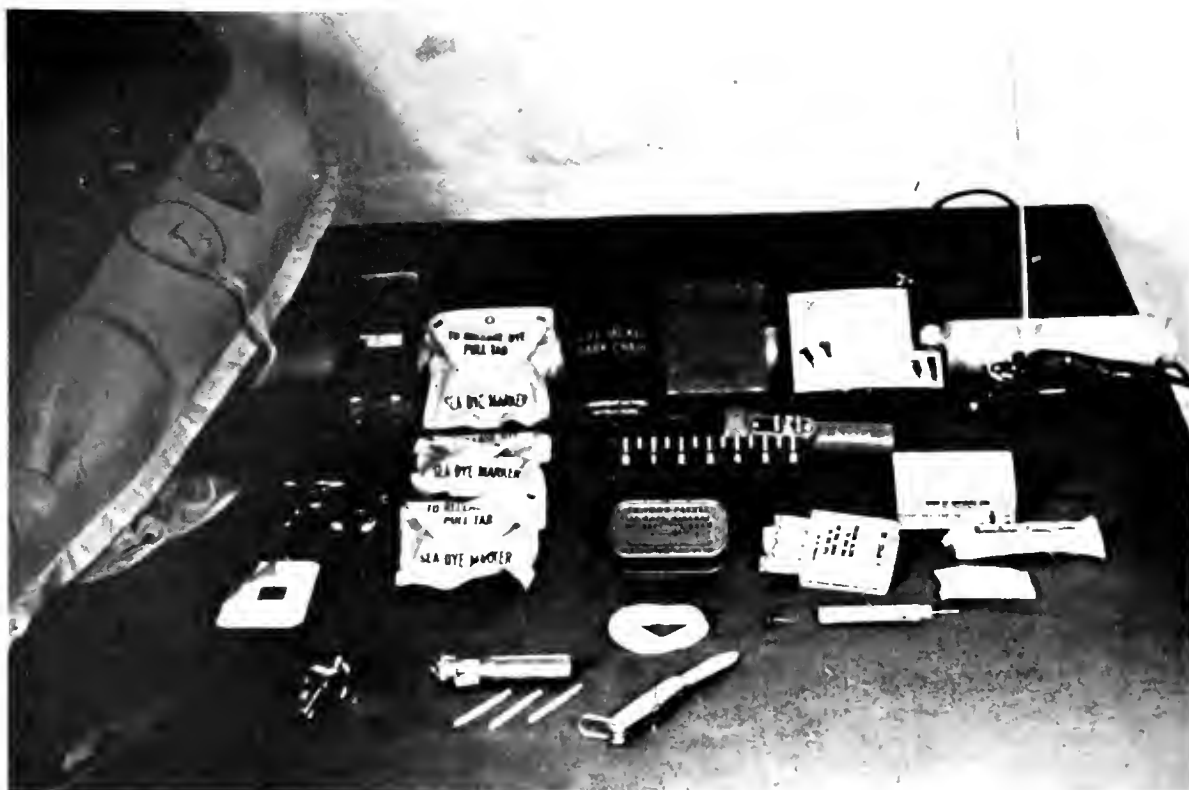
FIGURE 3-9.—Survival kit components.

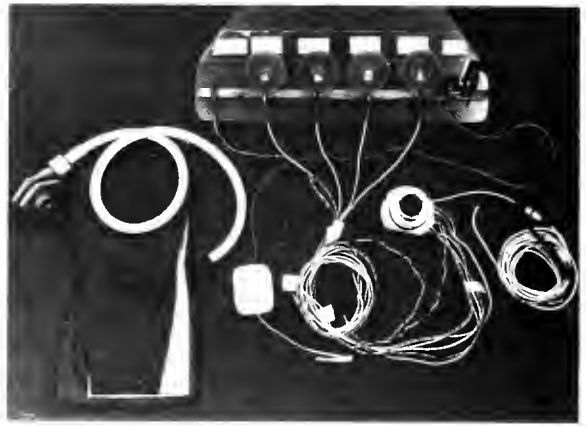
FIGURE 3-15.—Flight sensor harness.

The ECG sensors consist of rings composed of silicone rubber. The rings are constructed

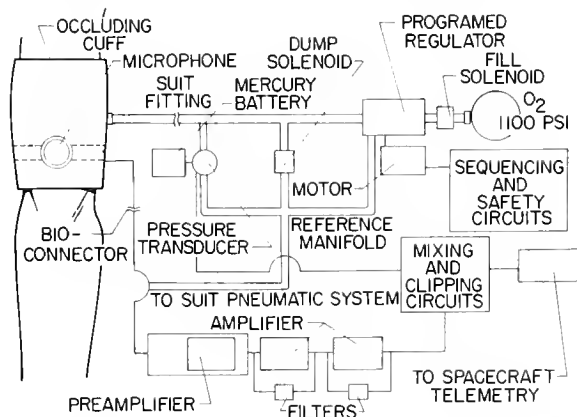
FIGURE 3-16.—Block diagram of automatic BPMS.

The original concept of the BPMS (fig. 3-16) was an automatic system, which would be initiated from a tracking station through the command receiver, by an automatic sequencing device onboard or by the pilot. The automatic system incorporated special safety circuits to dump the cuff pressure if the cuff stayed above

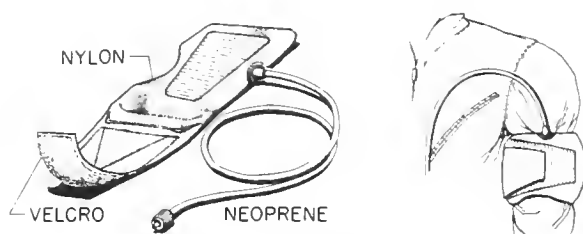
FIGURE 3-17.—BPMS cuff.

During the testing of the preliminary system on astronauts and other flight personnel it became evident that the standard 5-inch clinical cuff was unsatisfactory because of its stiffness, bulk, and the fact that arm movement was restricted. A new cuff (fig. 3-17) was devised by

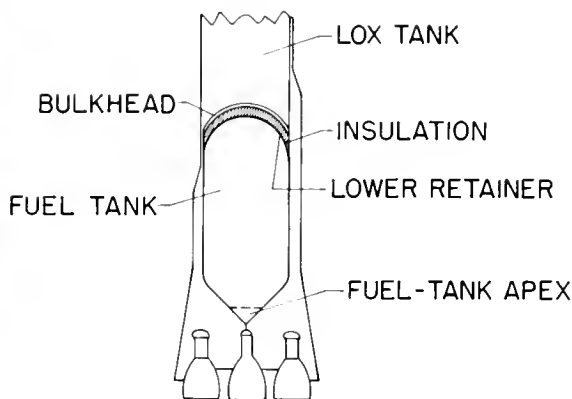
FIGURE 4-14.—Bulkhead between fuel and liquid oxygen tanks.

After electrical mating, the launch vehicle and spacecraft participate jointly in all tests. These tests are discussed in paper 5 on spacecraft preparation. The first attempt to launch MA-6 was on January 27, 1962. The launch vehicle was loaded with fuel on January 24. However, the mission was canceled because of excessive cloud cover in the launch area and was rescheduled for February 1; so the fuel tank was drained. On January 30, the fuel tank was again loaded; however, normal inspection procedures disclosed that the insulation-retaining bulkhead in the fuel tanks was leaking. Figure 4-14 shows a sketch of this bulkhead.

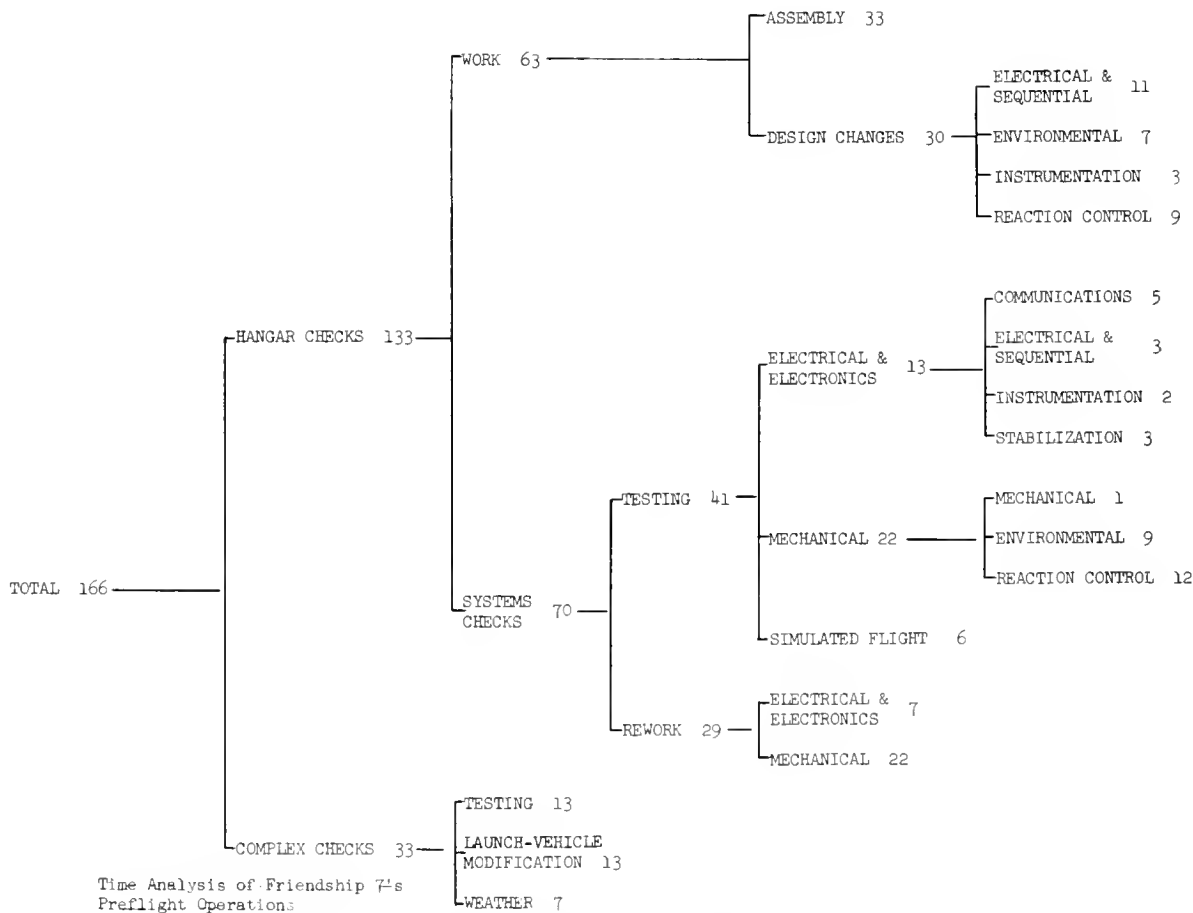
FIGURE 5-1.—Time analysis of preflight operations on Friendship 7.

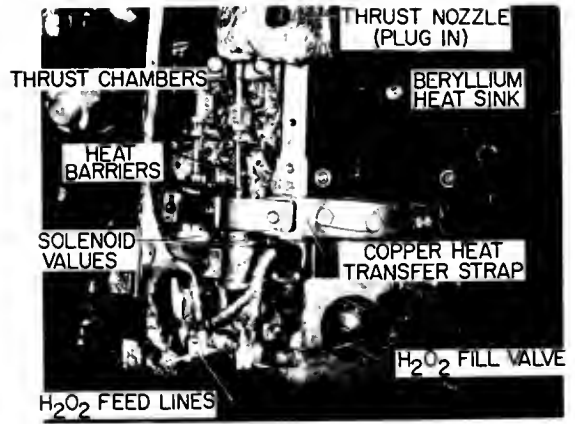
FIGURE 5-3.—Heat sinks added to roll thruster assemblies in reaction control system.

(2) Heat sinks were added to both manual and automatic roll thruster assemblies (fig. 5-3). Tests at McDonnell Aircraft Corp., St.

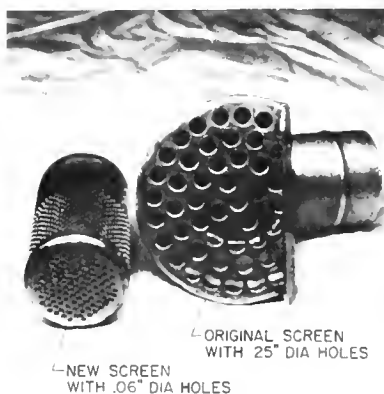
FIGURE 5-5.—Cooling fan duct inlet screens for Friendship 7 and Spacecraft 9.

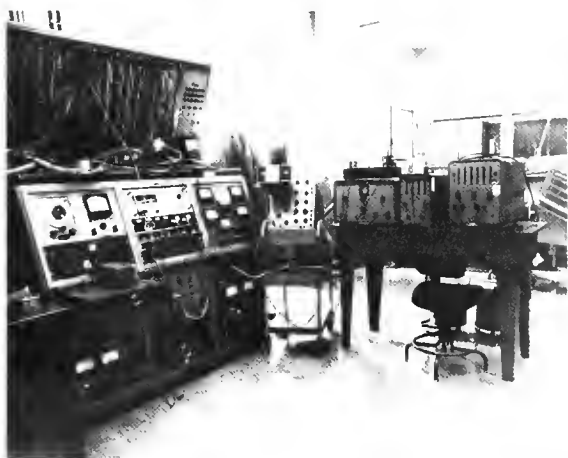
FIGURE 5-8.—Bench setup for testing spacecraft instrumentation.

The instrumentation system was thoroughly tested and calibrated on the bench as shown in figure 5-8 at Cape Canaveral prior to its installation in the spacecraft. The system was tested again after it had been installed in the spacecraft. The primary purpose of the latter test is fourfold: (1) to determine the error, if any, between the hardline signal normally used to transmit data to the blockhouse or other test equipment in the hangar and the signal radiated through the transmitter; (2) to determine possible system interference with the system operating in the spacecraft; (3) to make a sin-

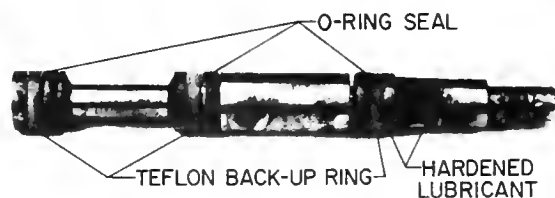
FIGURE 5-9.—High-pressure shutoff oxygen valve stem shown with hardened lubricant.

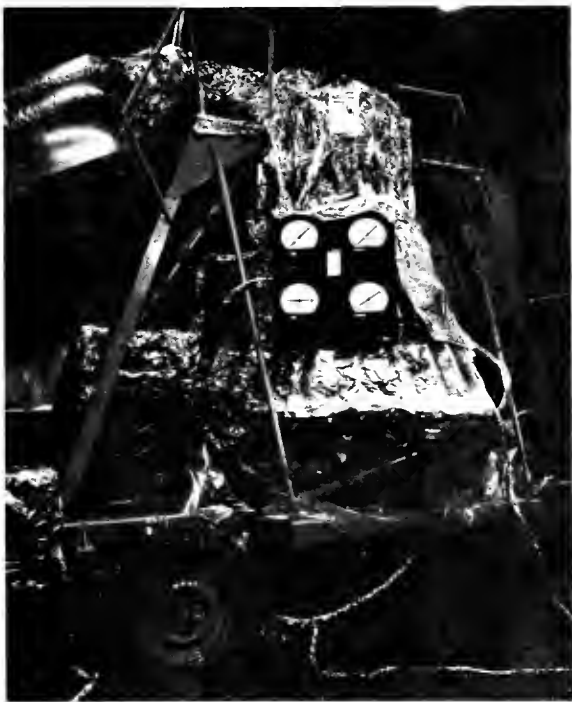
FIGURE 5-11.—Spacecraft in reaction control system facility for functional test of system.

The reaction control system (RCS) checkout procedure determined the condition and operation of the RCS system. Tests were conducted in a special test cell (fig. 5-11). Several gas checks were employed to determine the overall

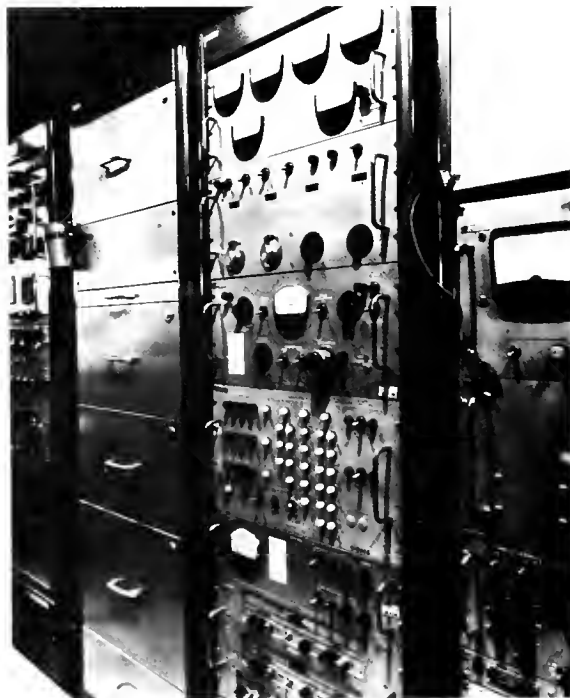
FIGURE 5-14.—Automatic checkout equipment for checking logic of autopilot.

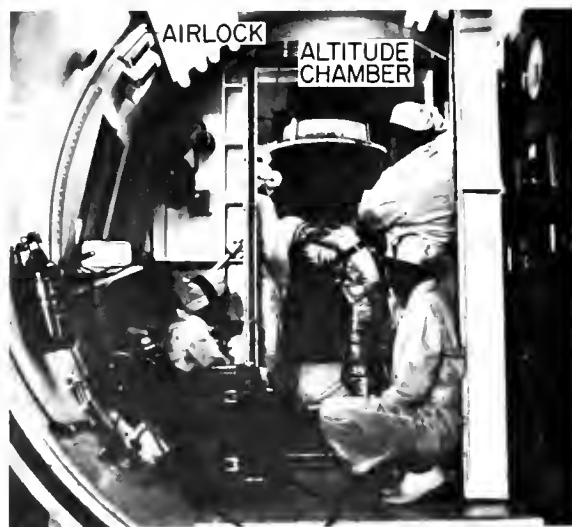
FIGURE 5-15.—Overall evaluation of the environmental control system in altitude chamber.

The altitude-chamber tests (fig. 5-15) were used to determine the operating characteristics of the overall environmental control system (ECS). The astronaut was suited and connected into the ECS for the first time during the altitude-chamber tests. The chamber was pumped down to a simulated altitude of ap-
